Manhole Inspection Summary

Manhole # S59CC_002MH

Insp Date: **6/6/08 8:23 AM**

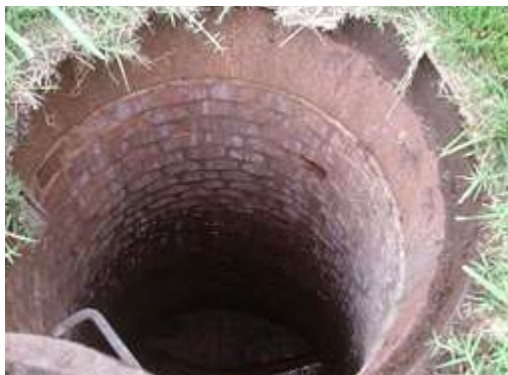
Defect 1

☒ **Leaks**

Infiltration Stains

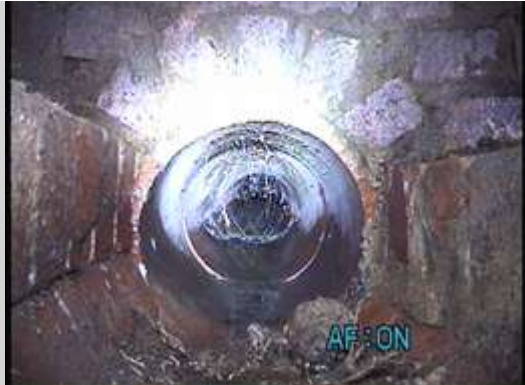
12 O'Clock Outflow

8 in. Circular Gravity Sewer
Pipe Out @ 12 O'Clock

Pipe Height: **8.4** (in.) Rod and Bar (Angled)
Pipe Material: **Clay** ☐ Pipe Lined
Invert Depth: **9.50** (ft.) Flow Characteristics: **None**
Deposits: ☒ None ☐ Mud ☐ Sludge ☐ Debris ☐ Grease
Silt Depth: (in.) Deposits Extent:
Infiltration: **None** Pipe Seal Cond: **Sound**

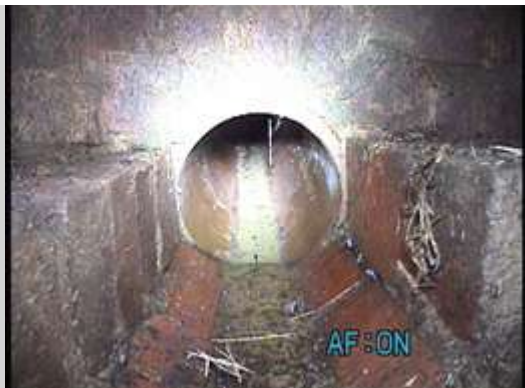
5 O'Clock Inflow

6 in. Circular Gravity Sewer
Pipe In @ 5 O'Clock

Pipe Height: **6** (in.) Rod and Bar (Angled)
Pipe Material: **Clay** ☐ Pipe Lined
Invert Depth: **9.10** (ft.) Flow Characteristics: **None**
Deposits: ☒ None ☐ Mud ☐ Sludge ☐ Debris ☐ Grease
Silt Depth: (in.) Deposits Extent:
Infiltration: **None** Pipe Seal Cond: **Sound**

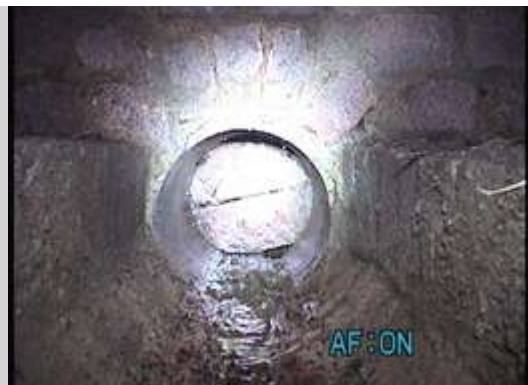
6 O'Clock Inflow

8 in. Circular Gravity Sewer
Pipe In @ 6 O'Clock

Pipe Height: **8.4** (in.) Rod and Bar (Angled)

Pipe Material: **Clay** ☐ Pipe Lined

Invert Depth: **9.45** (ft.) Flow Characteristics: **None**

Infiltration: **None**

Pipe Seal Cond: **Sound**
